APPLICATION STORY

Avoiding collisions in port and in open water

Cement carrier installs thermal imaging camera to avoid deadly accidents

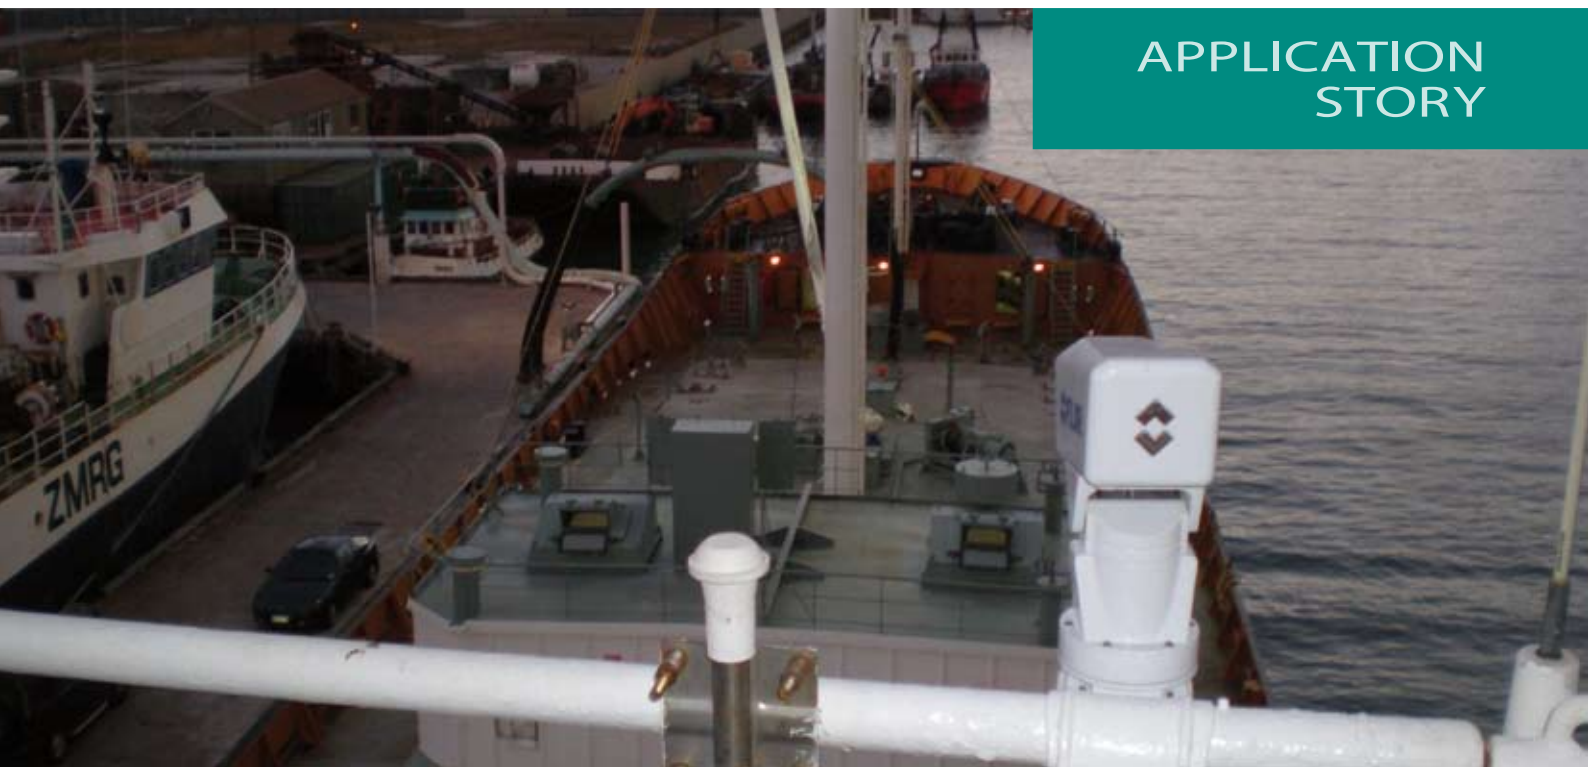
The FLIR Systems Navigator Pan / Tilt was installed just above the bridge of the M.V. Golden Bay. It helps the crew to avoid deadly accidents.

"Our customer opted for a FLIR Systems Navigator Pan/Tilt thermal imaging camera," explains Mr. Kershaw of Absolute Marine, the distributor of FLIR maritime products in New Zealand. "On the M.V. Golden Bay it was easily installed just above the bridge, which gave the camera a terrific uninterrupted perspective. The FLIR camera is approximately 15 metres above sea level and despite it being at a distance of over 70 metres to the bow of the ship, its performance is quite remarkable. Its thermal images are projected on a 20" overhead LCD screen which is installed on the bridge."

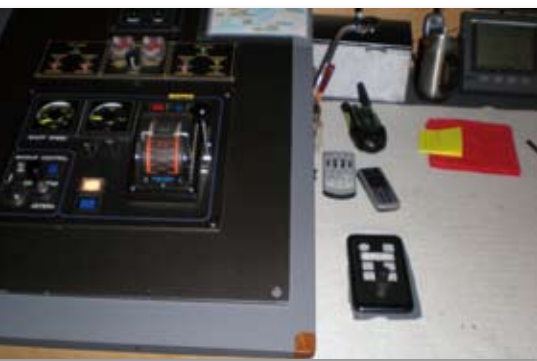
The Joystick Control Unit for the Navigator Pan / Tilt is integrated in the bridge.

"We have three people on the bridge when we enter port," explains Captain Robinson. "When entering at night the Duty Officer is responsible for the FLIR system and he monitors our progress while operating the joystick control unit which turns the Navigator Pan/Tilt in the desired direction. The Navigator Pan/Tilt is a great tool. It produces a crisp image in total darkness on which the smallest of details can be seen. A small vessel is easily detected at a range of practically 1000 metres which gives us enough time to change the course of the ship if necessary. Thanks to its ability to pan 360° horizontally and tilt +/- 60° vertically, we can scan either side of the ship and verify our exact position against channel markers. It greatly improves our situational awareness."

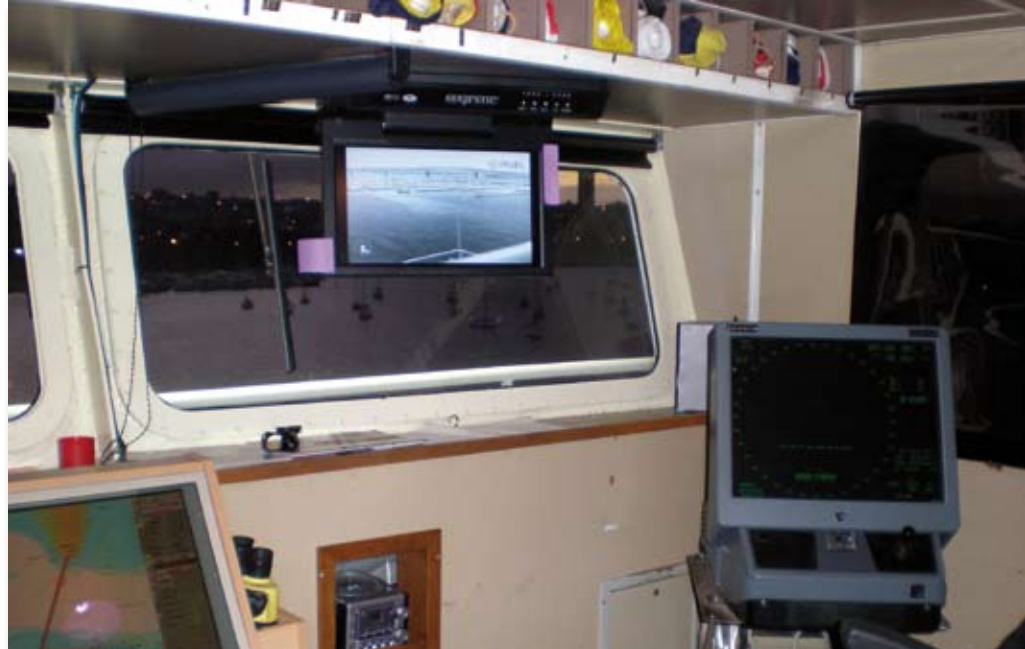
The FLIR Systems Navigator produces a crisp image which is projected on a 20" LCD screen installed on the bridge.

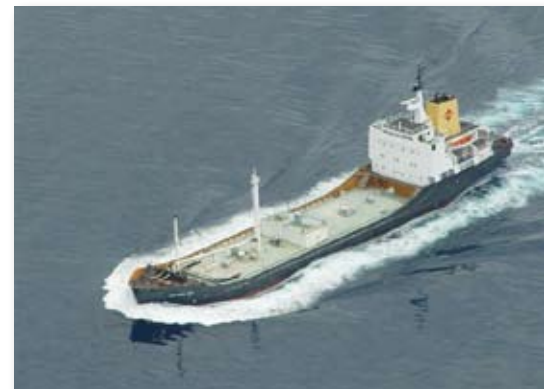
The M.V. Golden Bay: a cement carrier with a capacity of 4,500 tonnes.

The cement carrier used by the Golden Bay Cement Company is the M.V. Golden Bay with a capacity of 4,500 tonnes. Needless to say that it is not always easy to maneuver a ship of this size and weight. It takes some time to change direction and slow down.
